#### Figure 7 STAGE I PCB RESULTS IN SOIL AND CONCRETE - MARCH 2014

MOLINE STREET PCB SITE  
AURORA, COLORADO

**ATTACHMENT A**  
**ASBESTOS BUILDING INSPECTION REPORT – 2/24/2014**

**Location: Buildings B, C, D, E, F, G, H, and I, 3555 Moline St., Aurora, CO 80010**

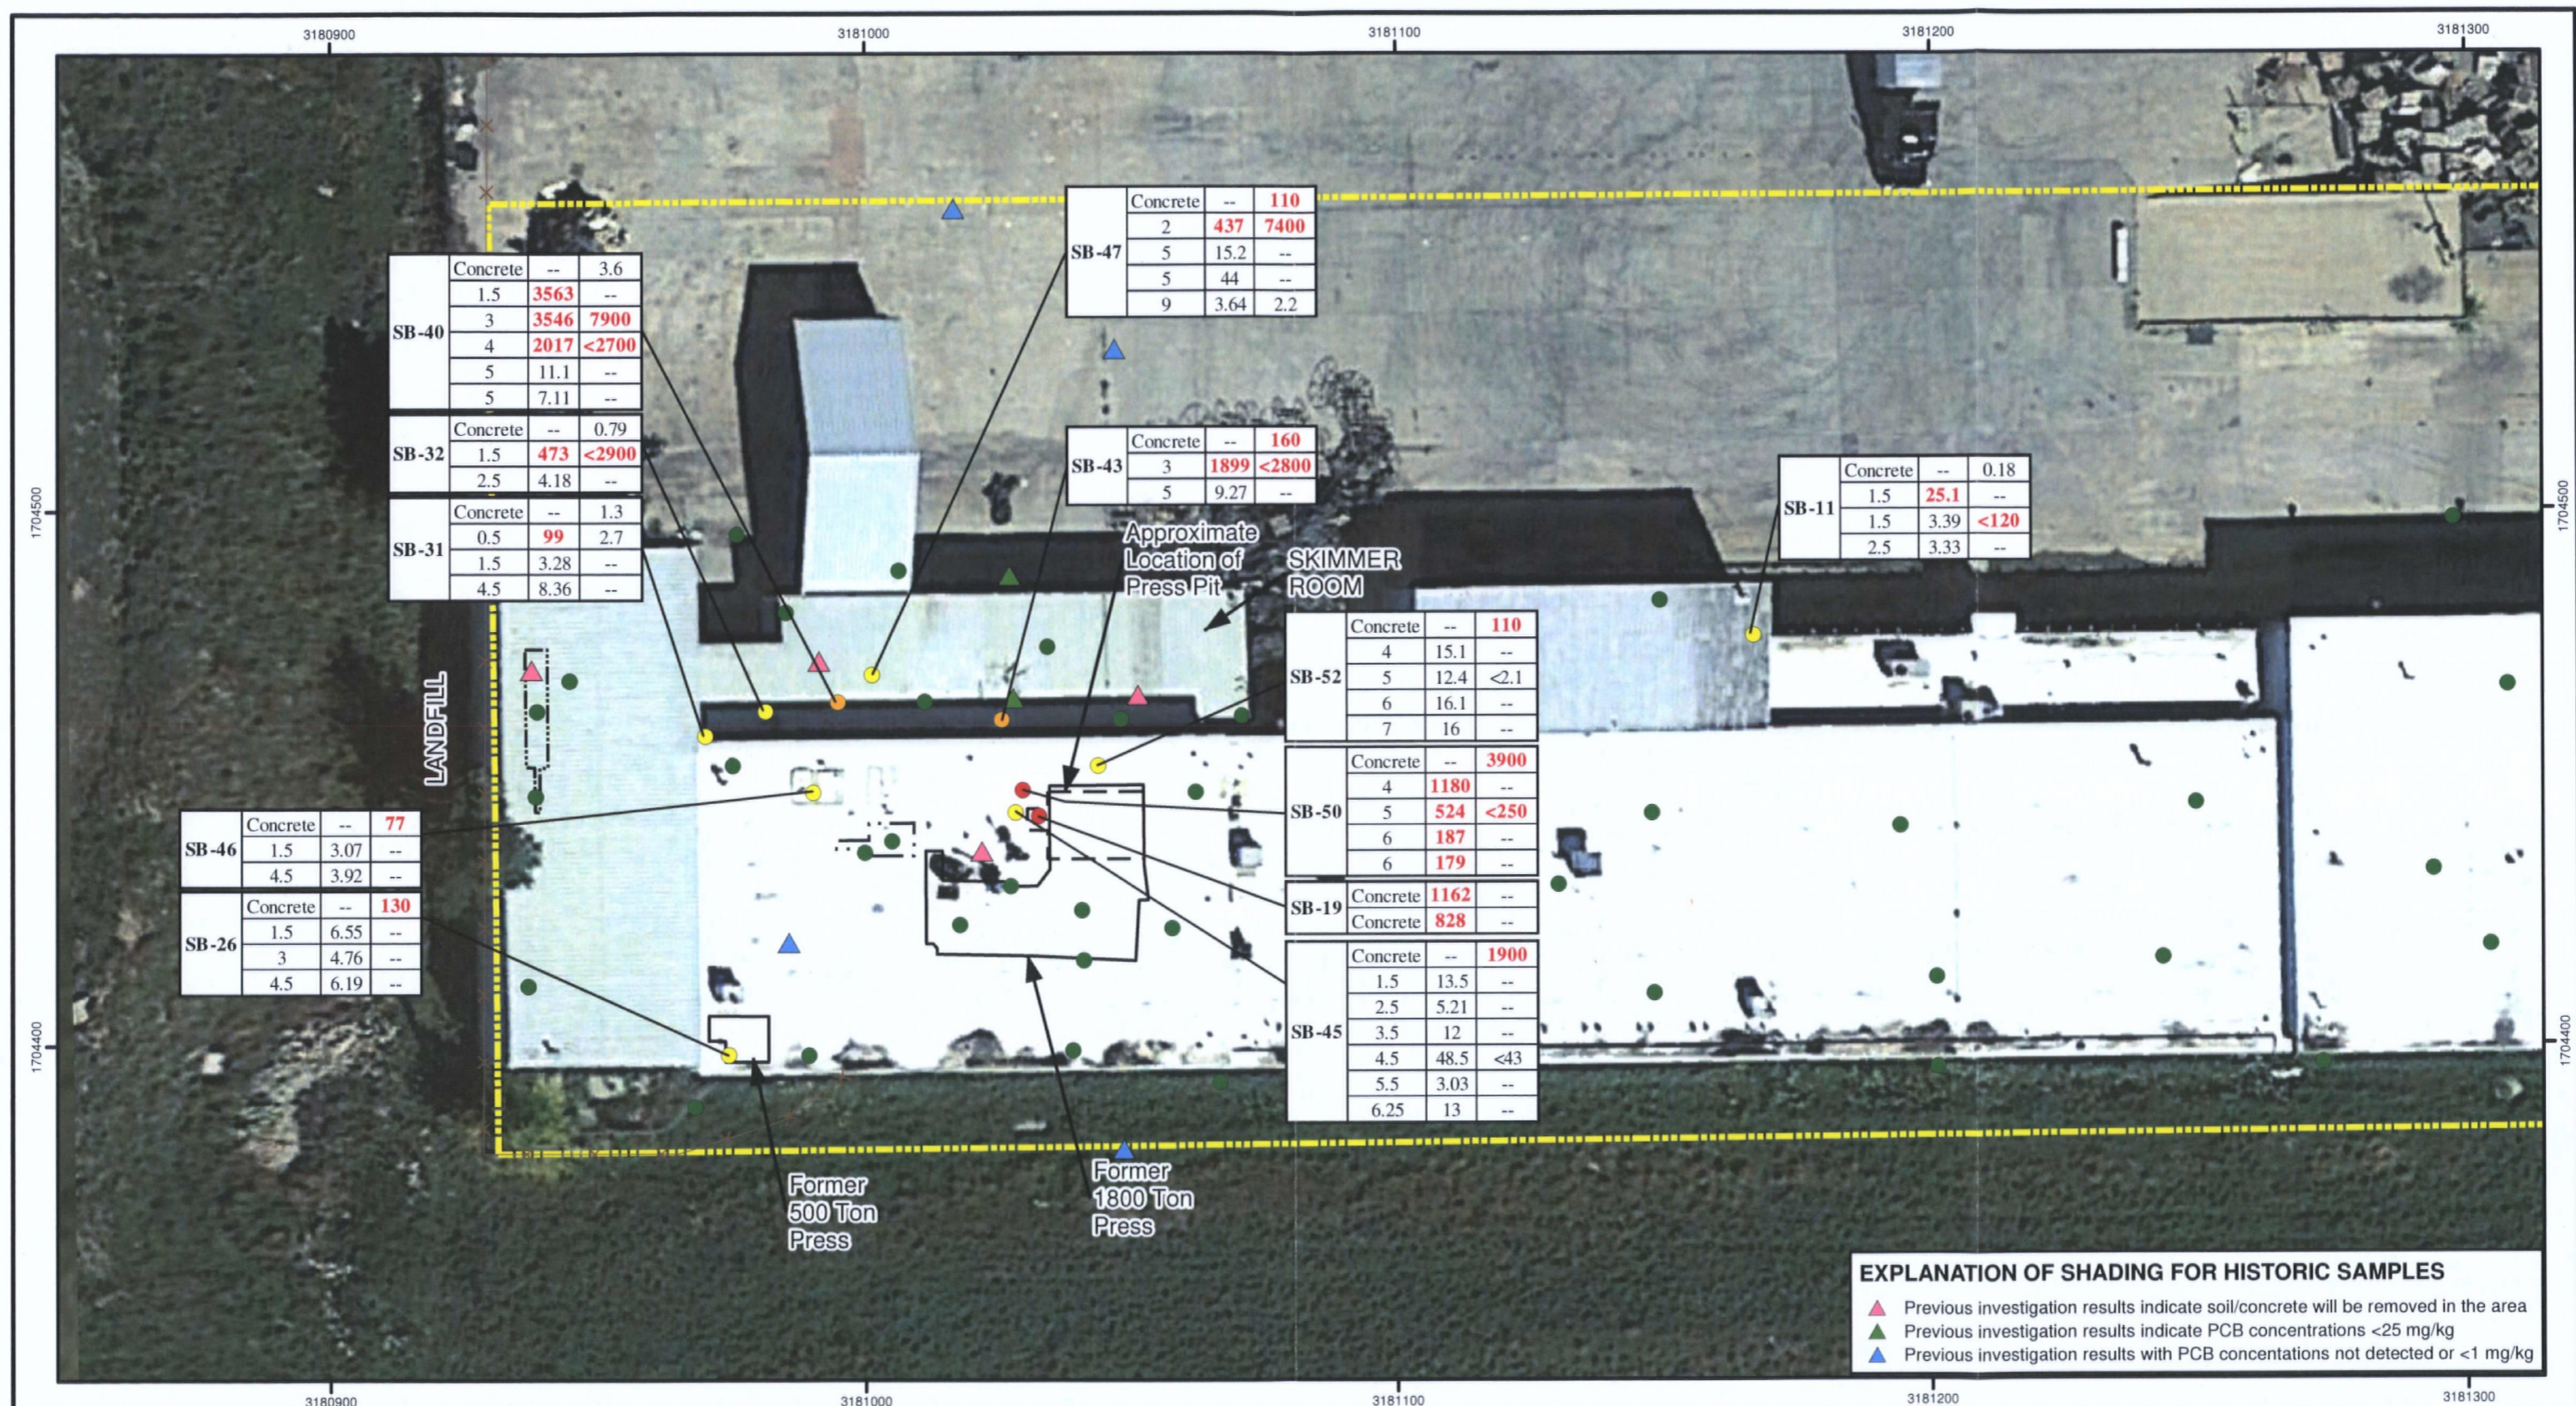
Results are posted only for locations that have one or more exceedances.

Note: red bolded entries indicate that concentrations either exceed 25 ppm in the upper 1 foot of soil or exceed 100 ppm below 1 foot. Where two results are present for the same depth interval at a location, the second result represents a field duplicate.

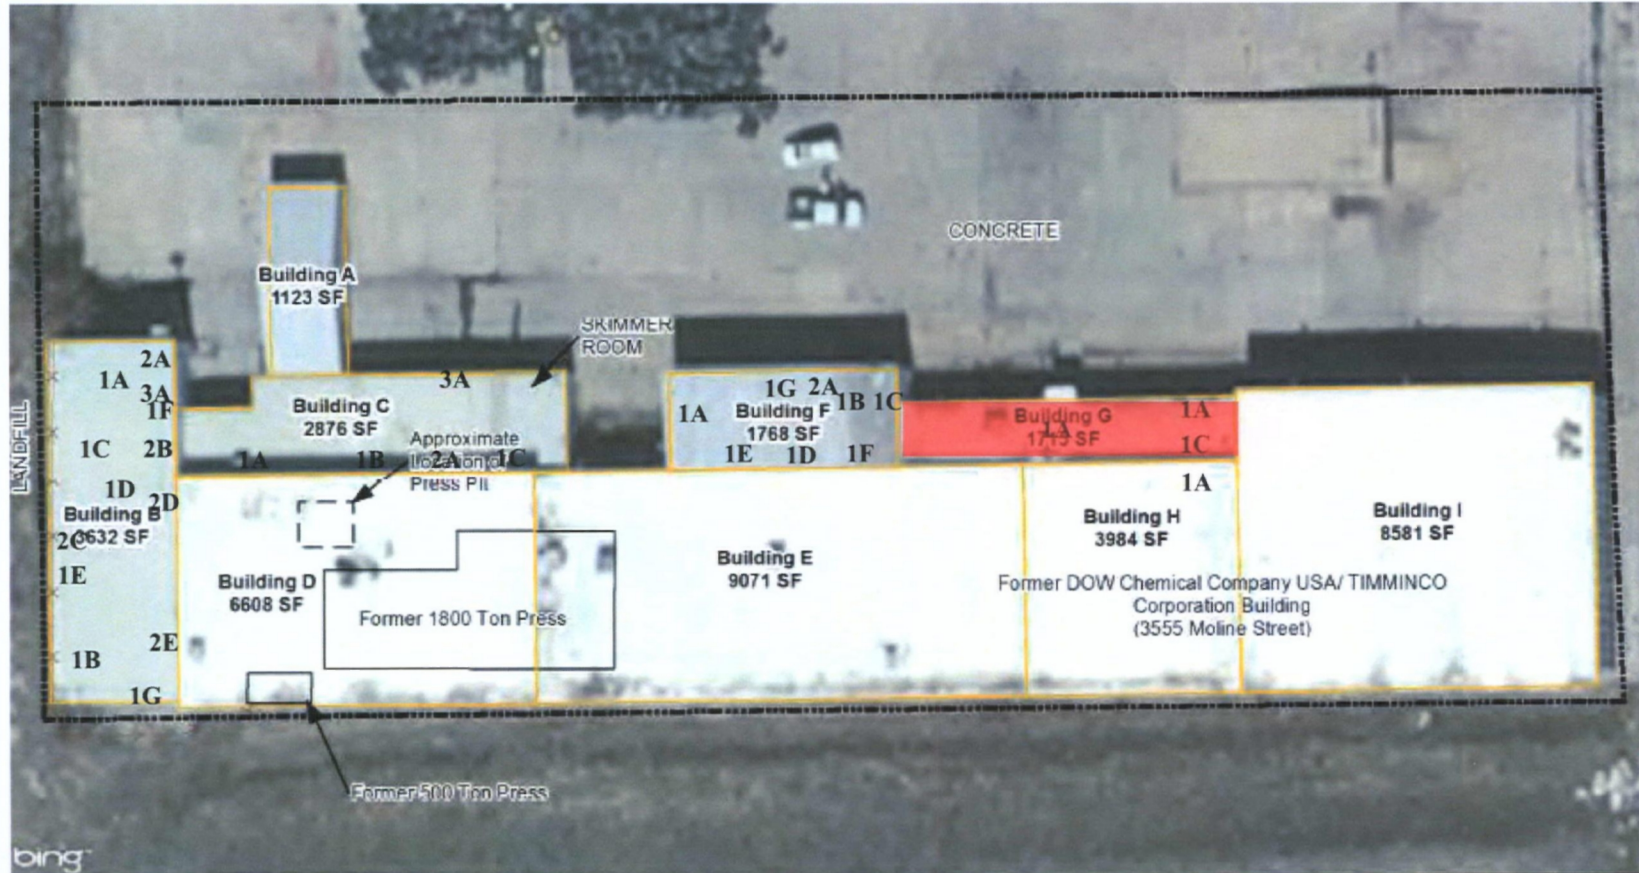
Asbestos ( $\geq 1.0\%$ ) Floor Tile
